House Condition Survey 2015/16: Analysis of energy efficiency data

Report prepared for the Energy Efficiency and
Conservation Authority (EECA)

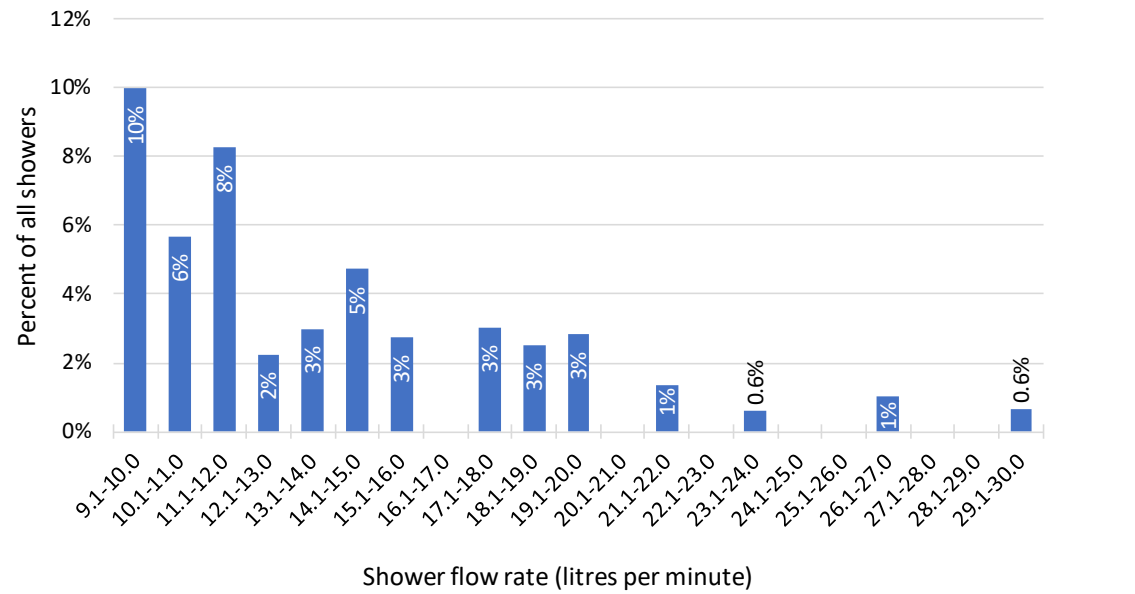
Figure 5. Proportion of showers with flow rates greater than 9 litres per second

EECA recommends a shower flow rate of 9 litres per minute or less. Some 46% of houses surveyed had at least one shower with a flow rate greater than 9 litres per minute (Table 3). This equates to nearly half of all showers recorded in the survey (49% or a total of 1.02 million showers) with a flow rate greater than the level recommended by EECA. Nearly 15% of showers exceeded a flow rate of 15 litres per

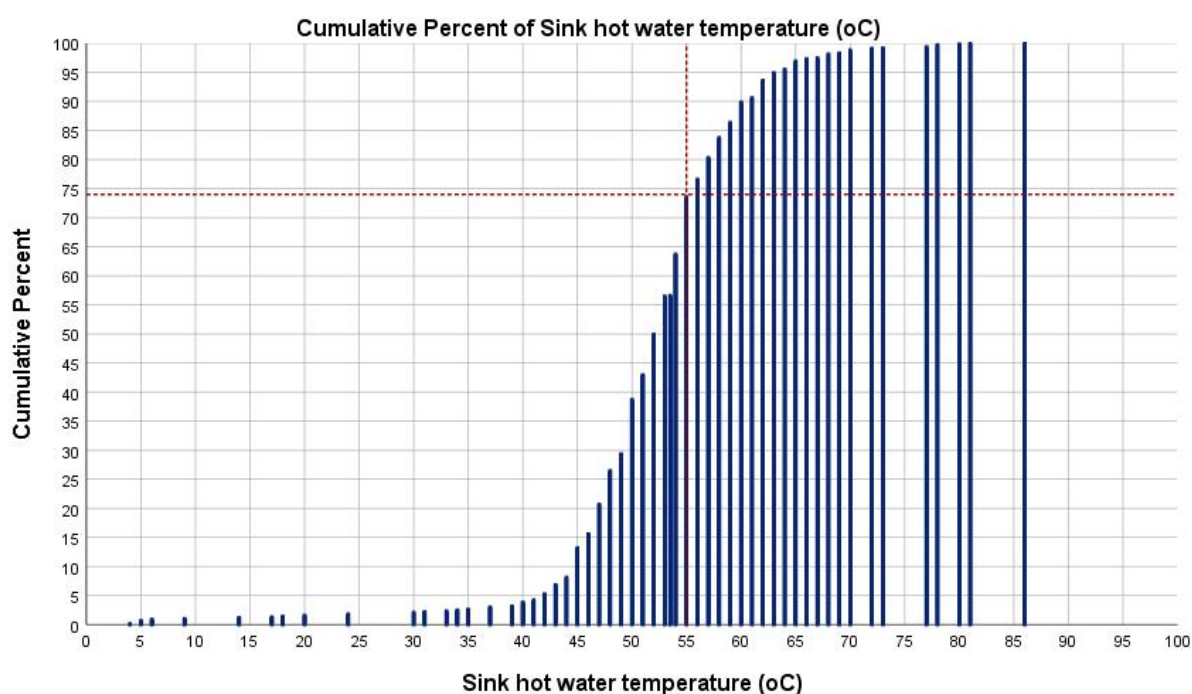
Figure 9. Cumulative percent histogram of all bathroom sink hot water tap temperatures. Dashed lines mark the proportion of taps above and below 55°C

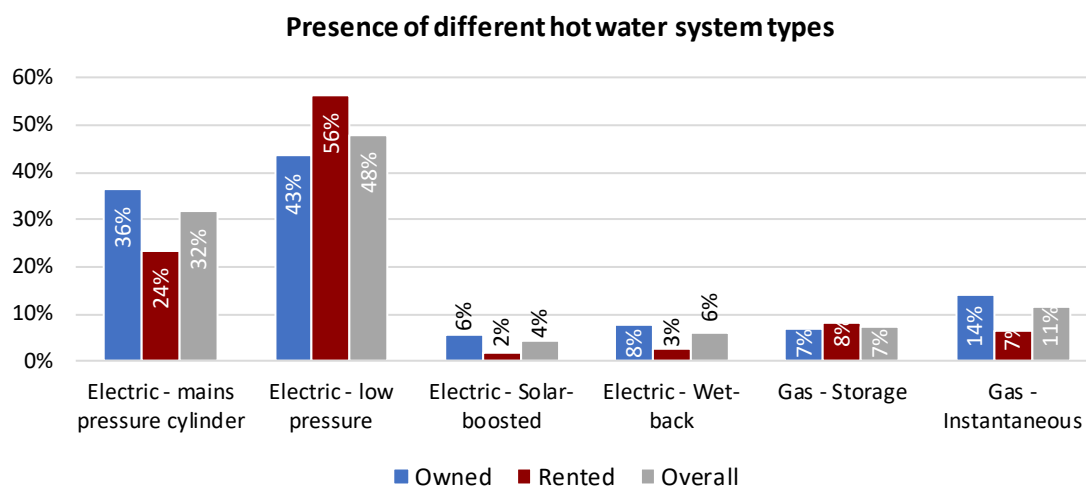
Figure 10. Presence of different hot water heater types by tenure and overall

The most common hot water system type, in both owned and rented houses, was an electric low-pressure system, present in 48% of houses surveyed (Figure 10). These were slightly more common in rentals, while electric mains pressure systems were more common in owner-occupied. Twice the proportion of owner-occupied houses had an instantaneous gas hot water heater (14% compared to 7% of rentals).

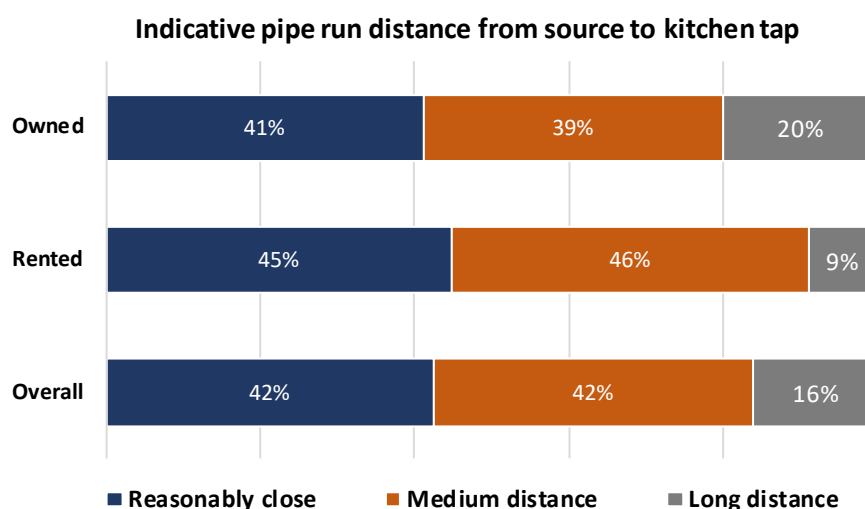
Figure 12. Indicative pipe run distance from the hot water source to the kitchen tap

The House Condition Survey provides an indicative measure of the hot water pipe run distance from the source of the hot water to the kitchen tap. Distance is measured on a descriptive, proxy scale of:

This information is recorded for up to two different hot water systems in the house. This data has been cleaned so that the information provided below applies only to the hot water system that supplies the kitchen tap. Owner-occupied houses were more likely to have longer distances between the hot water source and the kitchen tap. This could be related to the size of the house – 33% of owner-occupied houses had four or more bedrooms compared to 16% of rentals, and the average (mean) floor area of the owner-occupied houses surveyed was 170m² compared to 136m² for the rentals.²
